**ADA Compliance Report Completed by the
Massachusetts Office on Disabilities
On the entrance and library facilities
At Sawyer Hall
April 14, 2022**

Subject: Heath - Free Public Library - Access Limitations - Follow Up

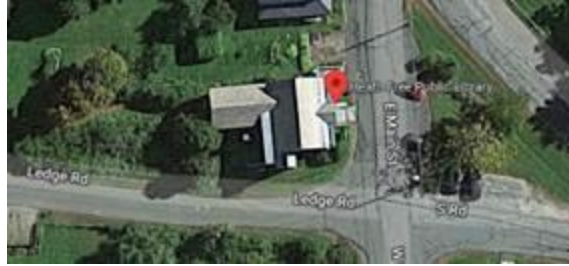
- While there are only 4 parking spaces provided across the street, one of the existing spaces would need to be designed as van-accessible but not reserved only to people with a plate or placard. (No signage required). This is a 2010 ADA Design Standard obligation.
- Someone visiting the Library needs to cross the street to access the ramp. The crown of the road, although not currently under the jurisdiction of the MAAB or ADA Design Standards, this is a significant issue as one must cross the street to access the entry point to the ramp, as mentioned below.

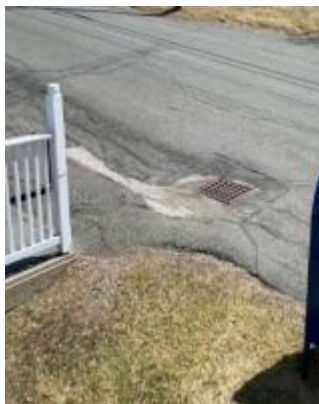
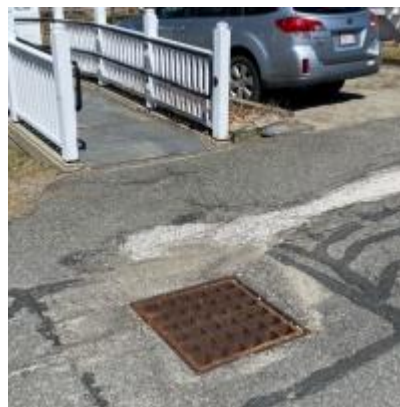
- The landing, or lack of a level landing at the base of the ramp,
 - Due to the degradation of the street, where the catch basin is located, as well as a significant sloped section that connects the street to the 1st ramp run section, this does not appear to be an easy fix. The street will need to be reworked to somehow provide a 5 foot level landing at the base of the ramp, or the ramp needs to be reconfigured, if even possible, to create some sort of ramped entry that does not involve the street. Other potential remedies could be the installation of an exterior lift that would, somehow, somewhere connect to the building. This is complicated due to the wetlands proximity to the building.

- The “Ashfield Stone” surface is heaving and settling, which in turn is creating changes in level over ½ inch in height,
 - To remedy this, the stone will need to be reset within the ramp, again, which will be an extensive project, especially if the slope of the ramp exceeds 8.3% and needs to be brought into compliance or the ramp configuration needs to be modified.

- The handrails of the ramp do not extend 12 inches beyond the end of the ramp.
 - While this may be a safety concern due to the ramps location to the street, I have significant reservations about a ramp discharging people onto an active street without a landing and handrail extensions.

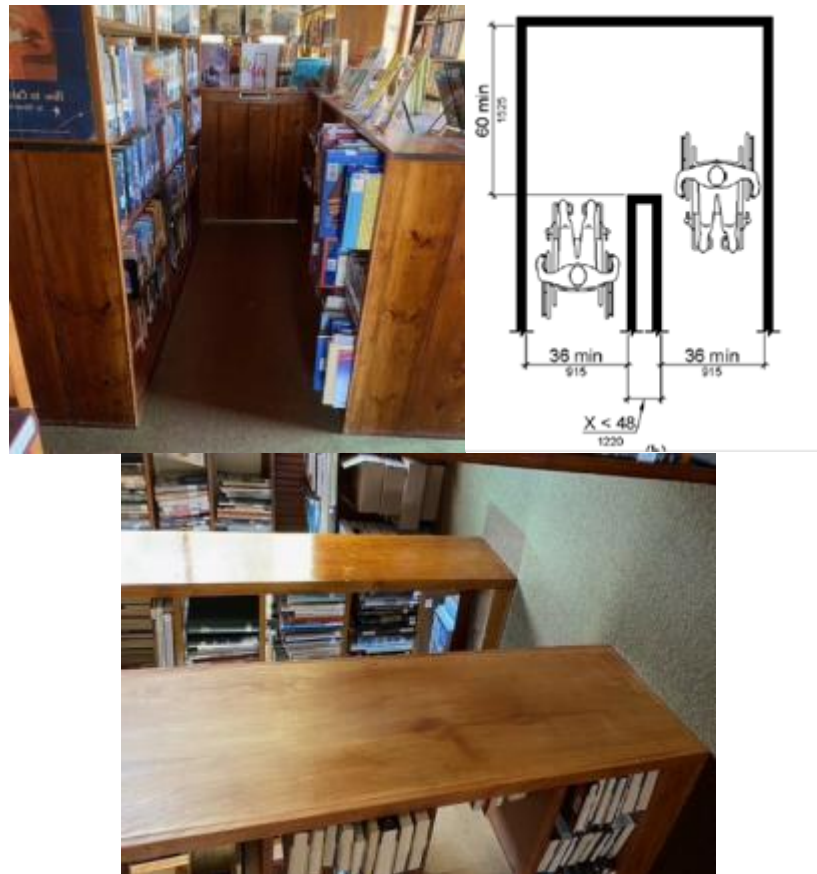
- The clearances that are required within the library, specifically the book stacks, are not adequately provided. Based on the configuration of the stacks, the actual width of the stacks themselves, and the “dead ends” at certain stack locations, a minimum of 36 inches must be provided between the stacks with a 60 inch turning area or turn must be provided at the ends of the stacks.
 - In order to provide the appropriate turning clearances within the current stack system, the stacks would need to be significantly reconfigured. As we discussed during the meeting, this could result in a 40% - 50% loss of available stack space due to the limited size of the building.
