Heath Town Facilities Committee

Final Report: Project Prioritization and Asset Status

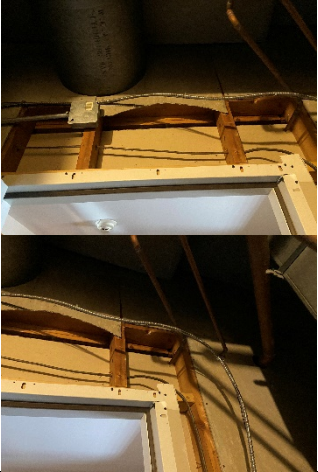
<p>Asbestos in Furnace Room</p> <p>Per analysis commissioned by Select Board, labeling required. No abatement to be undertaken until HVAC replacement Project.</p>			X				1

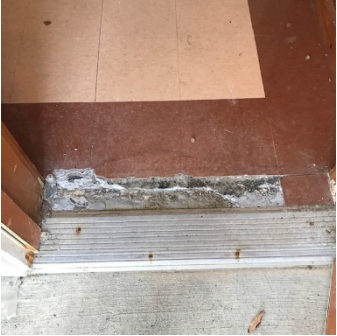
Repair Lower Entry Tiles			X				1
	Address Concrete Stair Entry			X			Quote solicited by Select Board for stair replacement.	1

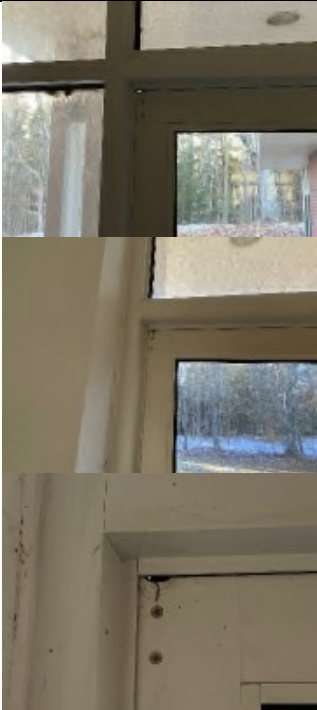
Repair door metal where cut to accommodate latch.			X	X		X	4

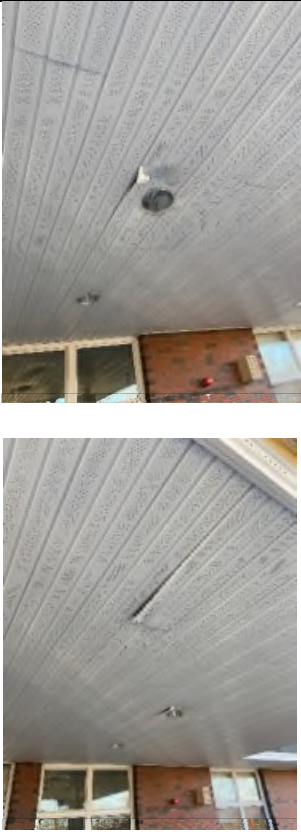
Repair Entrance Ceiling from Jackhammer Damage			X				1

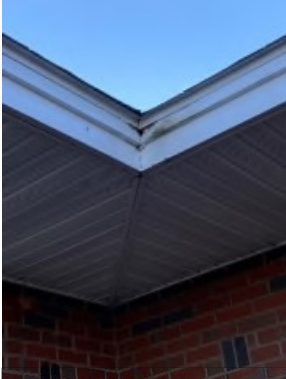
Repairs of Trim Near Loading Dock			X				1
	Fire Retardant Treatment of Banners in Atrium					X		-3

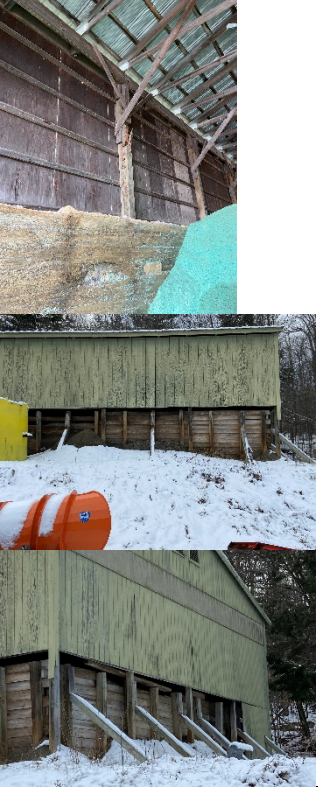
<p>Exterior Walls Buckling/Broken due to pressure from compacting materials.</p> <p>May not be cost effective if replacement is a viable option.</p>			X				1

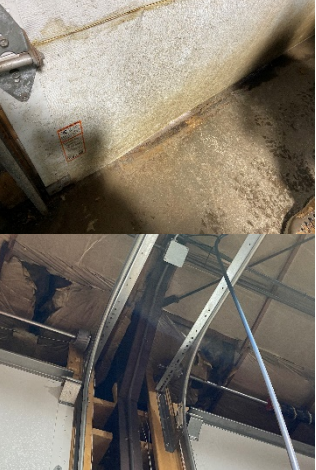
<p>Garage Door Repair and Maintenance</p> <p>Highway – repair or replace.</p> <p>Fire – complete replacement due to damage from trucks. Motors have no breaks, no safety stops, etc.</p>	X (re: Fire doors)		X				8
	<p>Size/Add Ventilation</p> <p>Existing fans blow out. Nothing pulls air in. Recommend heat recovery ventilation.</p>		X Per OSHA air exchange standards.		X		X	6

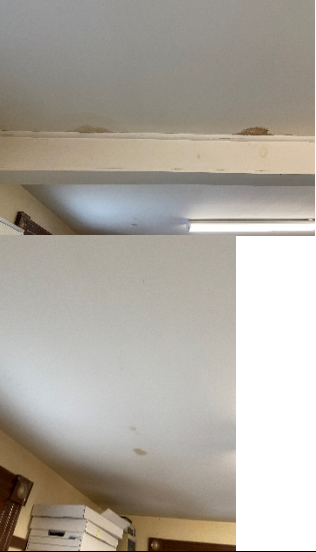
<p>Replace Metal Roof (EOC)</p> <p>Within Highway Dept. Capabilities. If not in conflict with existing job duties, could limit cost to materials only.</p>			X			X	2
	<p>Create Swale and clear trees behind building (Highway, Fire, EOS)</p> <p>May require discussion with adjacent property owner and raise takings issues.</p>						X	1
	<p>Repair Sheet Rock (EOC)</p> <p>Limited to stained ceilings and small holes behind desks.</p>			X		X		-2
